Test Report 检测报告

Sample
样品名称 3D TOF CAMERA
Model
样品型号 NYX660/DS86/DS87
Status of Sample
样品状态 In good condition
完好
Date of Receival
样品接收日期 2024.11.15
Test Date
样品检测日期 2024.11.15~2024.12.09

Test Item
检测项目 Damp heat, steady state Test,Cold,Damp heat,cyclic,Change of temperature,Shock,Free fall *
恒定湿热、低温、交变湿热、温度冲击、机械冲击、单体跌落*
Test Result
检测结果 See the body of the report
详见报告正文
Remark
备注 The test methods and test items marked "*" are not within the scope of CNAS accreditation of our laboratory.
带有"*"标记的检测方法和检测项目不在本实验室CNAS认可范围内。

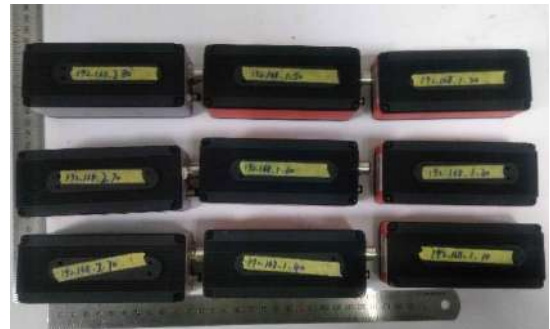
Reverse photo before test
 试验前反面照

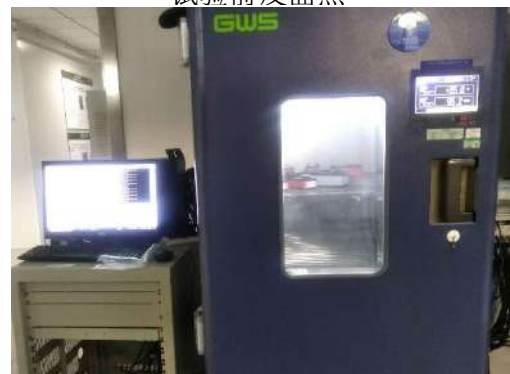
Sample work monitoring photo
 样品工作图

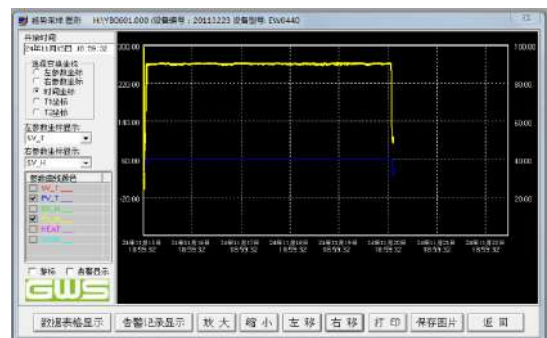
Trial curve
 试验曲线

STEP	小时	分钟	%C	温度 °C	湿度 %RH	开关
0	0	1.0	11	+25.0	50.0	00000000
1	0	35.0	0	+60.0	50.0	00000000
2	0	40.0	0	+60.0	90.0	00000000
3	120	0.0	0	+60.0	90.0	00000000
4	0	40.0	0	+60.0	50.0	00000000
5	0	35.0	0	+25.0	50.0	00000000

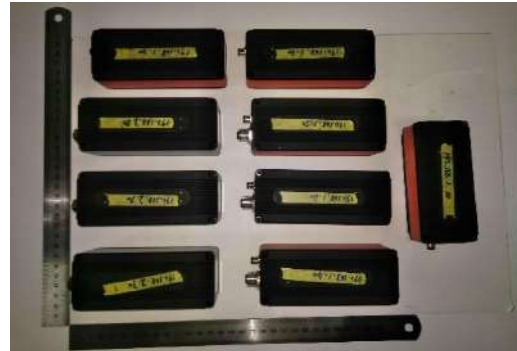
Reverse photo after test
试验后反面照

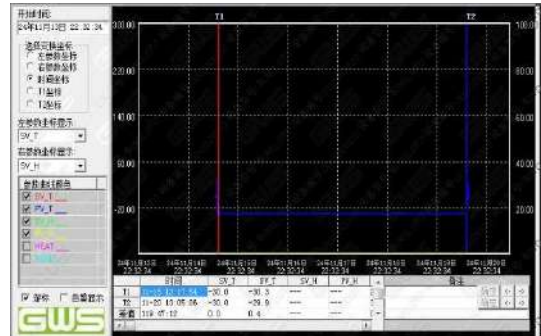
Trial curve
 试验曲线

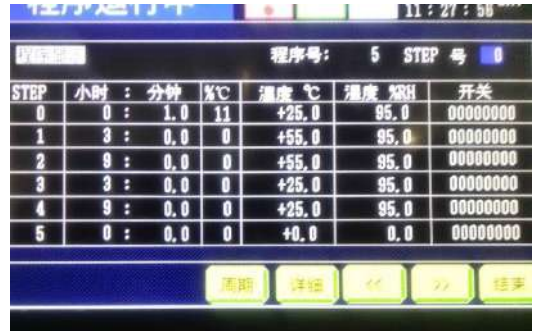
Test program setup
试验程序设置图

25°C 95%RH/9h~55°C 95%RH/9h, change time 3hours, 3 cycles, Sample work with voltage of 12V.

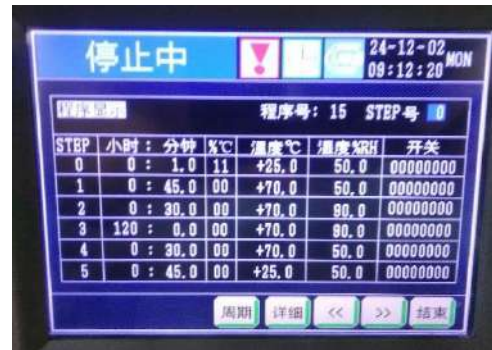
Test program setup
 试验程序设置图

70°C 90%RH,Storage 120h.

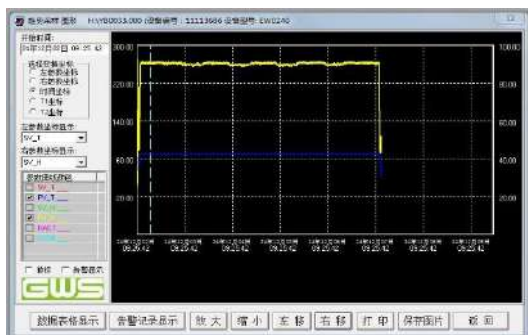
Trial curve
 试验曲线

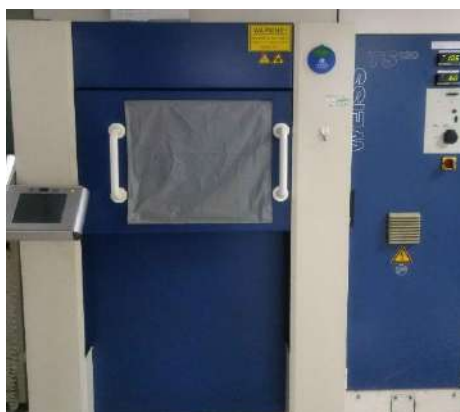
photo of test equipment
试验设备照

M-YB-0012 Thermal Shock Test Chamber Model:TS130

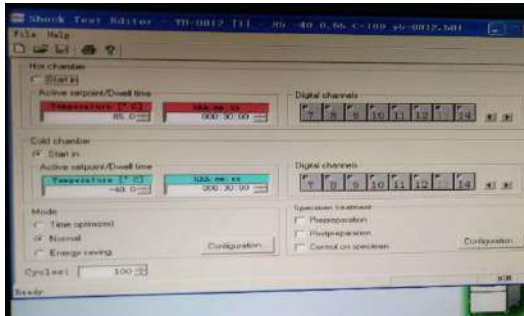
Test program setup
试验程序设置图

High Temp:85°C;Low Temp:-40°C;Each step duration for 30min;Transition : < 5 min;Cycle:100.

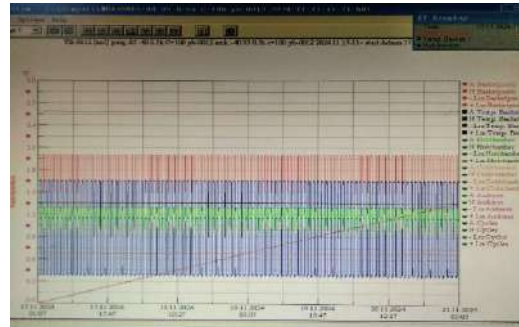
Trial curve
试验曲线

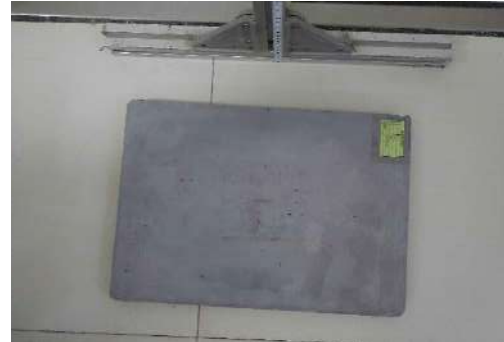
Drop surface
跌落面
